WARE INDUSTRIES MAIN (UPPER) DAM  
MA 00594

PHASE I INSPECTION REPORT  
NATIONAL DAM INSPECTION PROGRAM

DEPARTMENT OF THE ARMY  
NEW ENGLAND DIVISION, CORPS OF ENGINEERS  
WALTHAM, MASS. 02154

NOVEMBER 1978

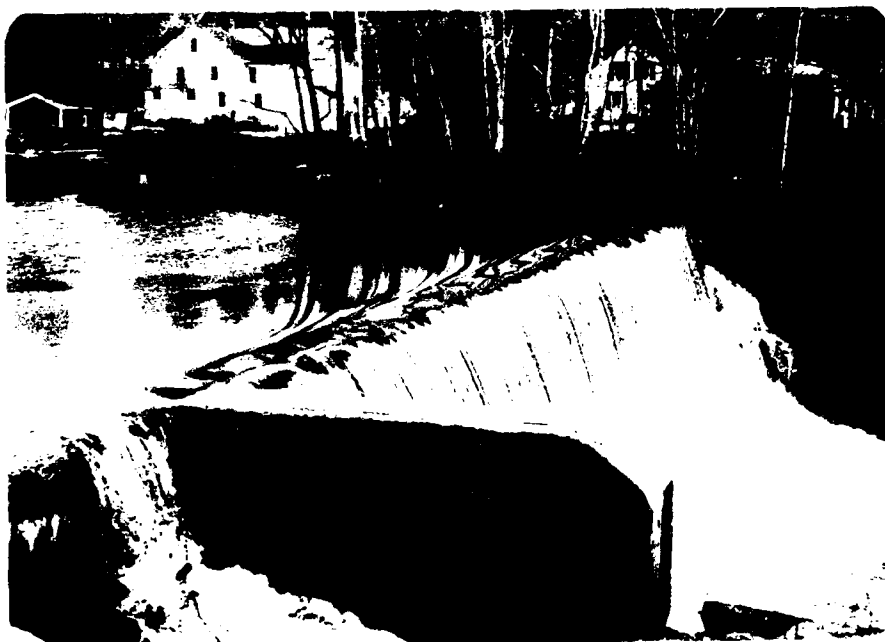
1. Overview of main dam

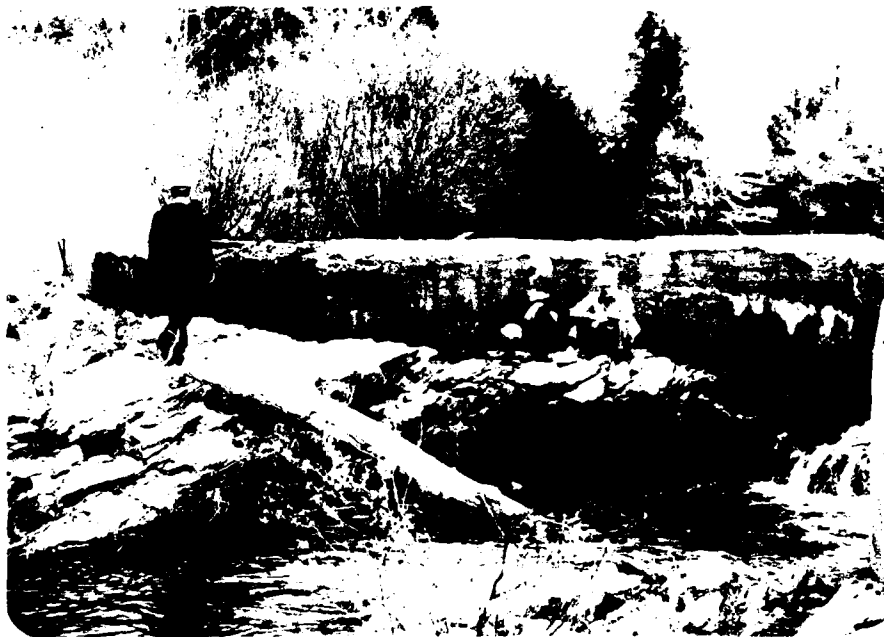
A spillway extension wall extends 50 ft. to the right from the main dam, Photo No. 4. Concrete shows considerable deterioration at the top edge and the vertical downstream face. The wall is undermined at the right end, Photo No. 5, and at the left end adjacent to the main dam, Photo No. 6. The wall exhibits cracks and efflorescence. The wall is 2 ft. wide at the top and has an upstream slope which was measured to be 2 horizontal to 1.3 vertical.

Although the concrete dam extension has deteriorated and is undermined, it is only 4 ft. high, has a broad base, and is founded on rock. Although a failure is unlikely, such a failure in the absence of failure of the main dam would not cause extensive damage downstream.

4. Downstream side of concrete dam extension

1. Repair the concrete surfaces on the concrete dam extension to prevent continued deterioration of this structure in the future. Loose weak concrete should be removed and the surface restored by the application of concrete mortar, shotcrete or other methods. Areas of contact with bedrock should also be restored.
2. Rebuild or otherwise stabilize the cut quarry stone wall at the right side of the emergency spillway. This wall may be stabilized by instituting the proposed revision to the emergency spillway as delineated on drawings now in the hands of the Owner.
3. Place mortar in open joints in the left side wall of emergency spillway to prevent loss of stone from this wall.
4. Renew the main supports for the gate house structure.
5. Clear the downstream channel of the emergency spillway of trees, brush and debris. Complete the clearing and brush removal downstream of the overflow weir.

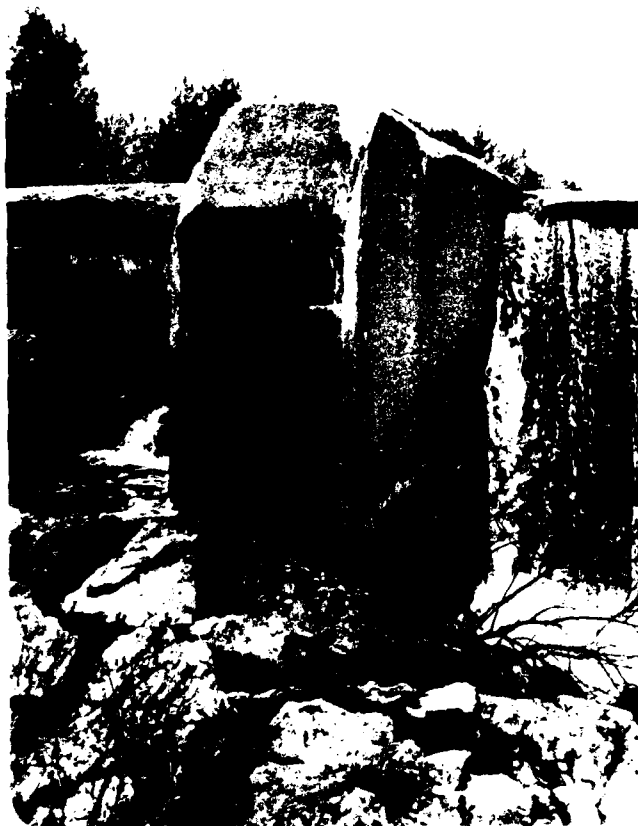
B. Dam. The view of the main dam (spillway weir) was obscured by flowing water during the inspection. The left side wall is constructed of cut granite masonry. A number of the blocks at the downstream end of this wall are loose and have fallen free, barely visible in Photo No. 2. The right wall of the main dam is constructed of concrete, Photo No. 3. The wall is undermined at the downstream end and has small spalls on the edges of the concrete, Photo No. 7.

7. Concrete pier  
between main dam  
and concrete dam  
extension

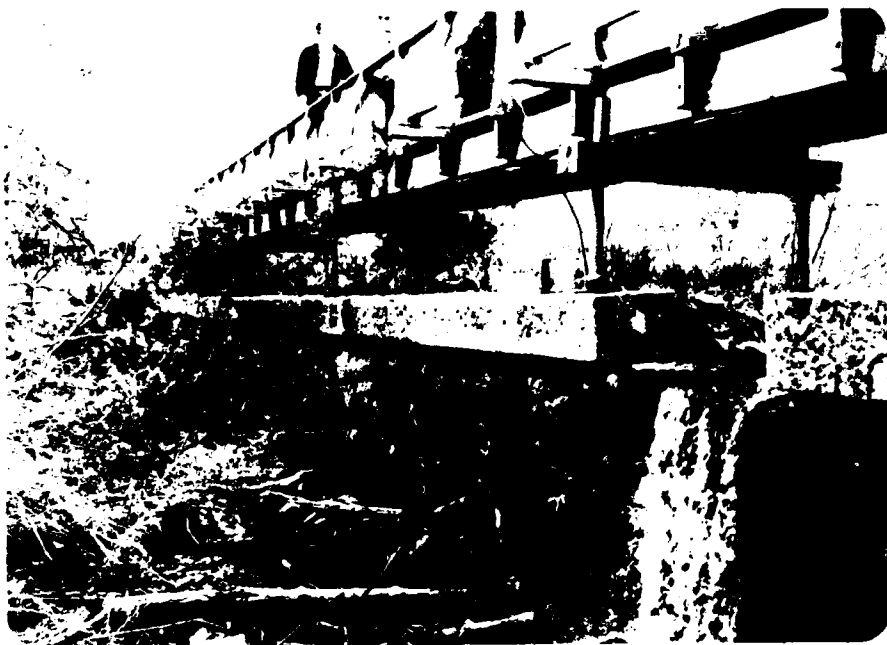
An overflow weir is present on the southeast side of the canal, allowing water to flow back into the main channel. The weir is made up of cut quarry stones for the main portion of the wall and a cut granite cap for the weir crest. One section of the cut granite cap has been removed to provide a pilot channel, Photo No. 8. Trees and brush has been cut recently downstream of the channel. They are presently piled in the channel itself. The access bridge which parallels the overflow weir is in good condition. It is of timber construction. Several of the pier caps for this bridge have cracked timbers. Conditions on the approach to the overflow weir are shown in Photo No. 9.

8. Overflow weir with wood walkway

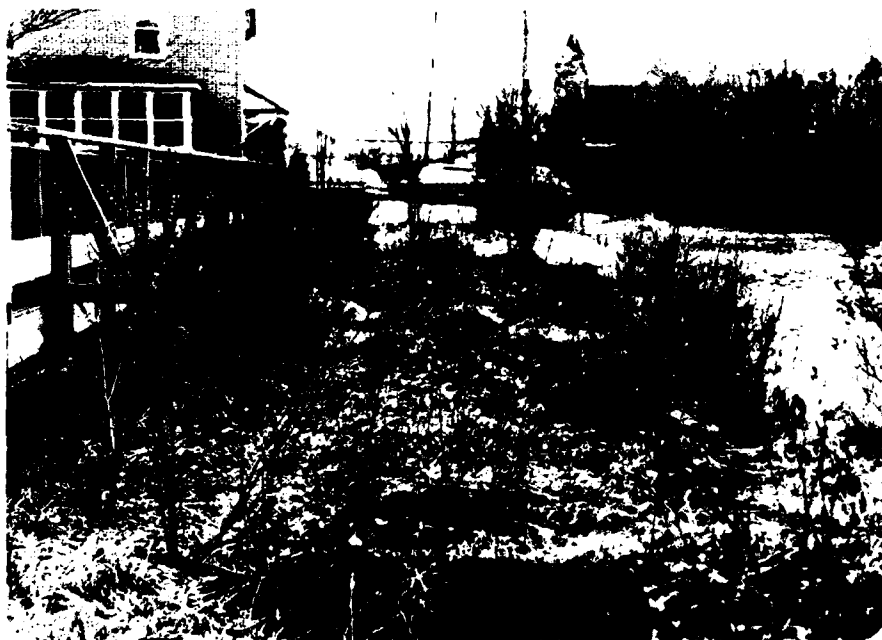
9. Approach to overflow weir from canal

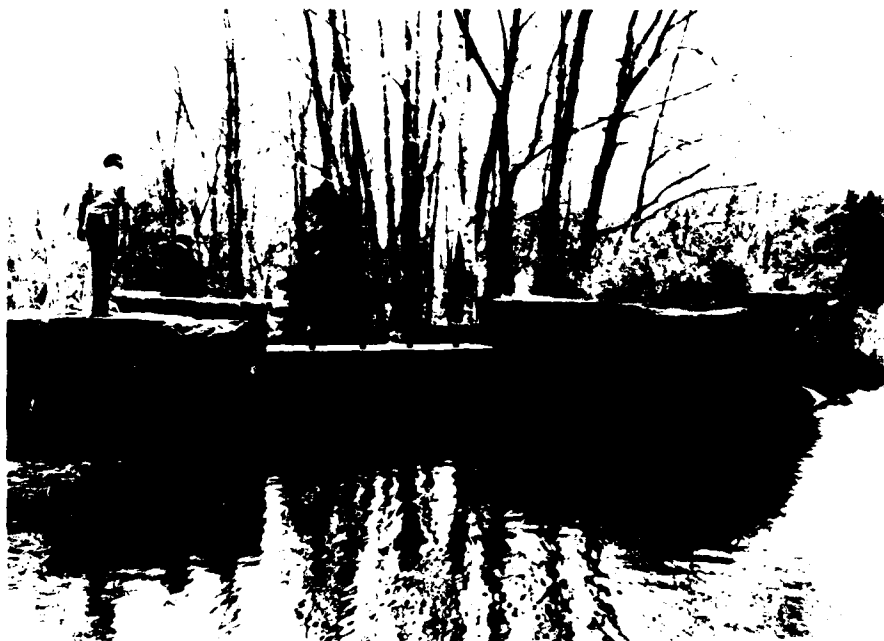
A separate concrete emergency spillway is located to the left of the main dam, Photos No. 10 and 11. The upper portion of the weir and concrete side walls are in good condition. The lower regions of the weir show considerable efflorescence. There is one large spall out of the face of the left side wall, Photo No. 12. In back of the side walls are cut quarry stone retaining walls. The left wall primarily, Photo No. 12, contains no mortar in the joints. The right wall, Photo No. 13, has mortared joints but the lower regions of the wall have failed. Stones have fallen to the channel invert below. This wall is considered to be unsafe and on the verge of failure. The downstream channel from the emergency spillway contains considerable debris at the toe of the weir and brush and young trees in the channel further downstream.

10. Upstream side of emergency spillway

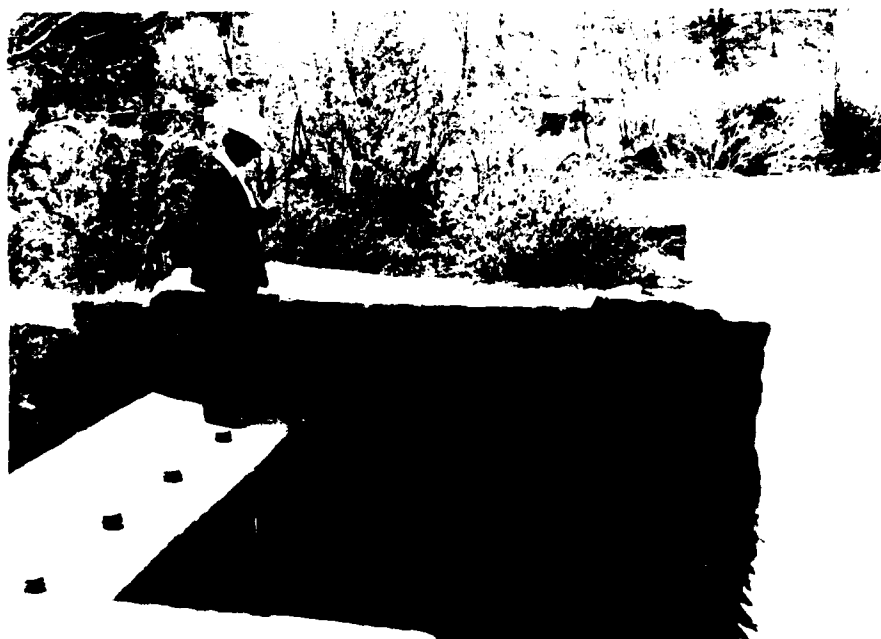
11. Right abutment of emergency spillway

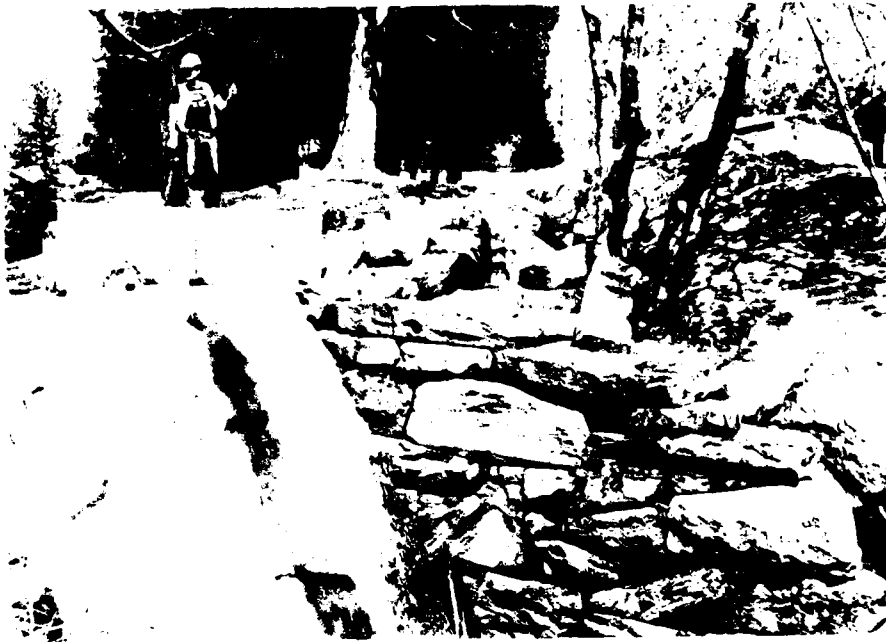
AREA EVALUATED	CONDITION
d. <u>Emergency Spillway</u>  General Condition	Sixteen-foot long concrete weir with concrete abutments in good to excellent condition. Masonry wall behind concrete abutment on left side has open joints. Wall behind right abutment downstream of weir has missing blocks and is on the verge of collapse

12. Stone wall below left abutment of emergency spillway
